AFGL-TR-84-0069

ANTENNA PERFORMANCE VERIFICATION AT LAUNCH SITE

A Feasibility Study on Preflight Performance Testing of Stripline Slot Arrays Mounted on a Rocket

Scientific Report No. 2

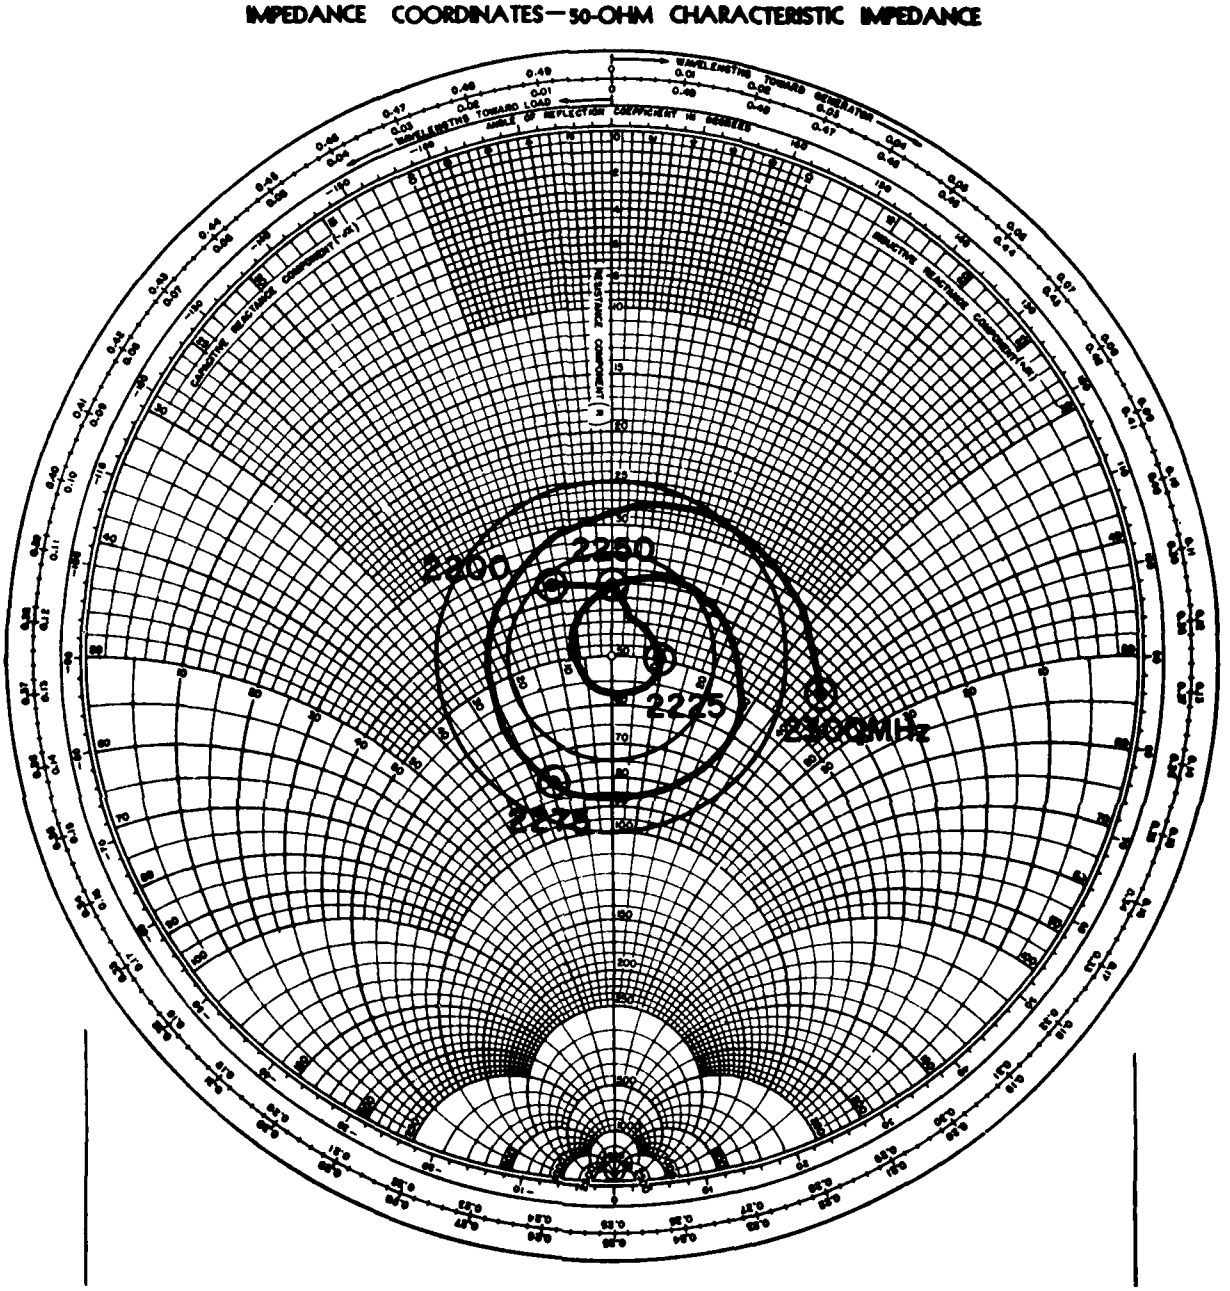
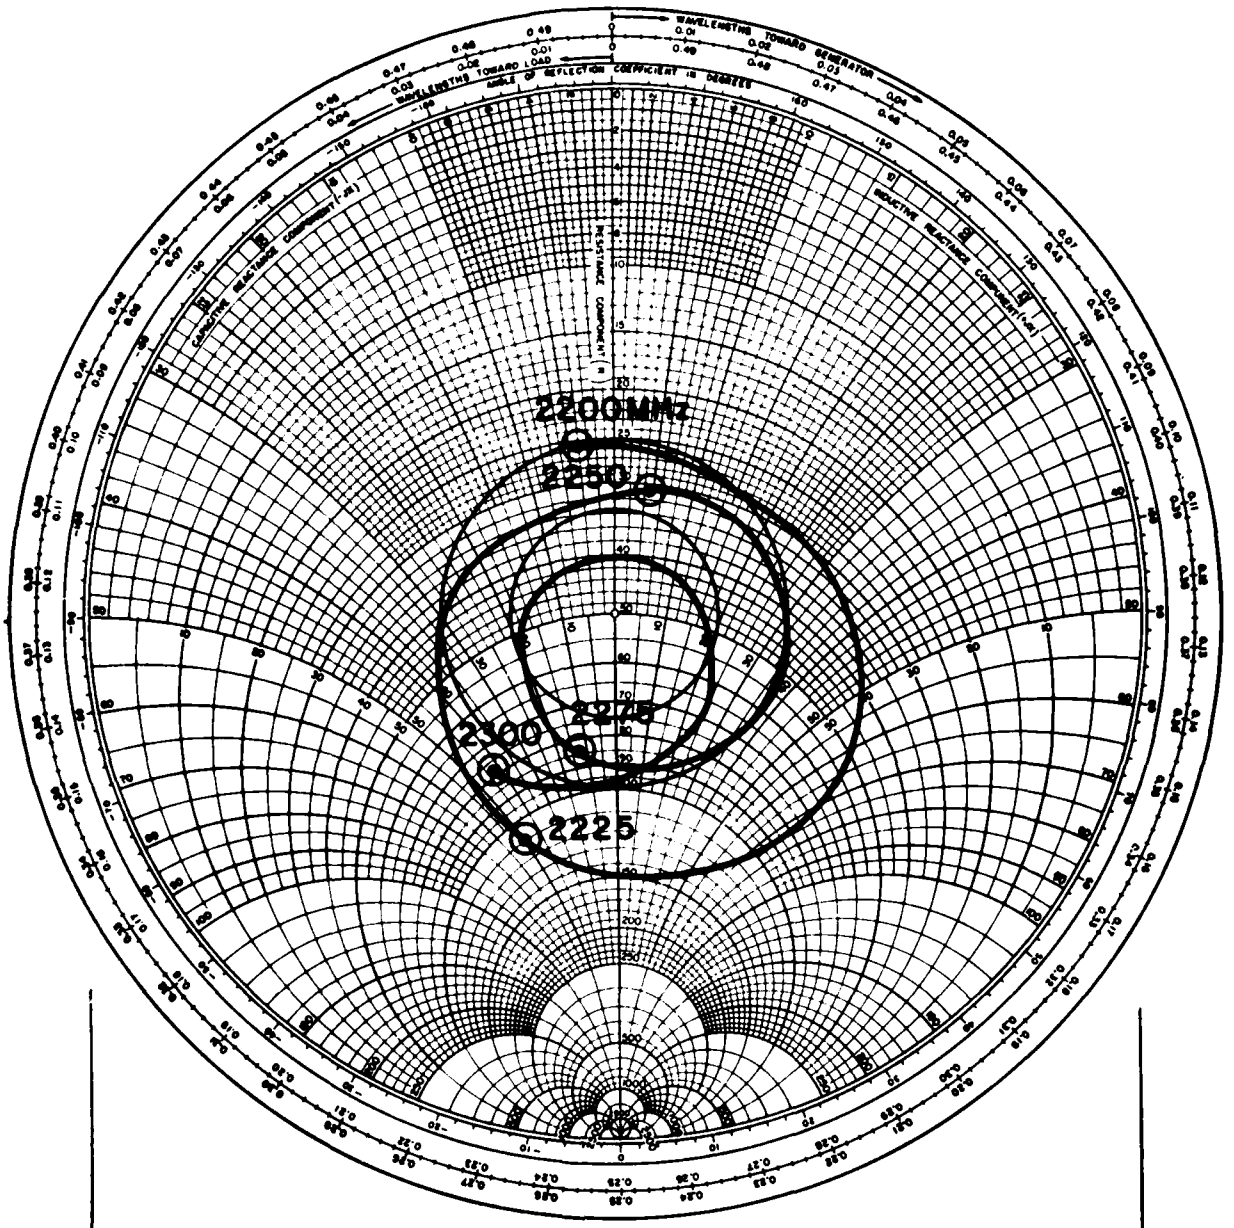
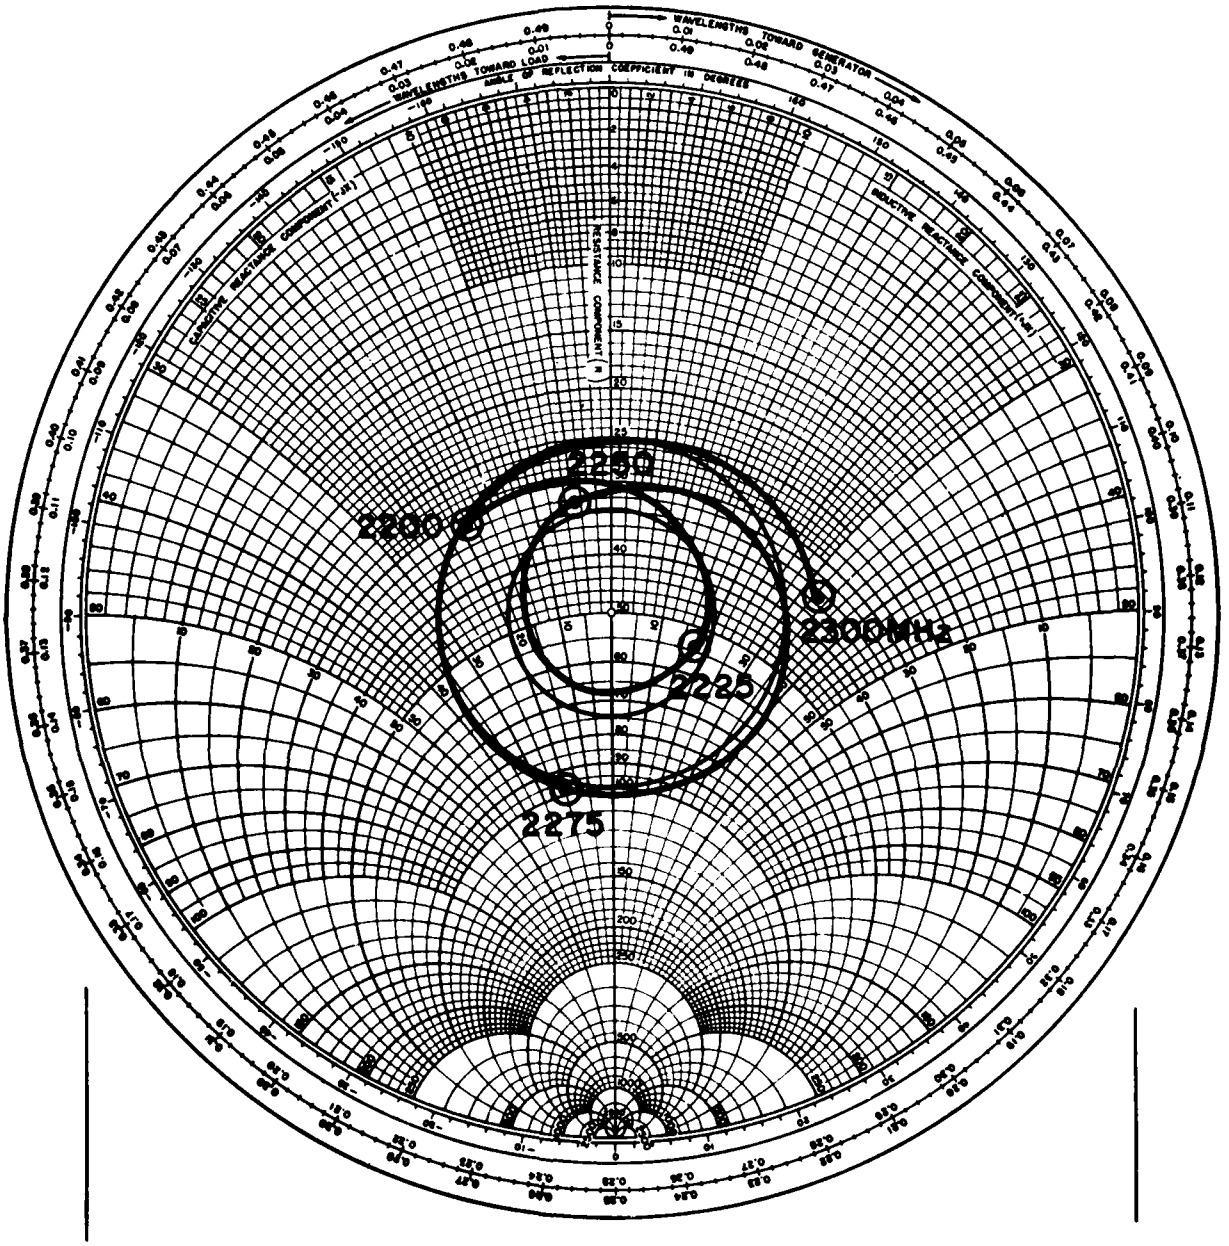
Before the tests at the antenna range were started, impedance measurements were made at the laboratory. Since radiation tests were planned for the intact antenna and also for a simulated damaged array, the impedances were measured for those antenna conditions. The results are shown in Figures 2 through 5. A comparison of the impedance curves shows that it would not be possible to detect a damaged subarray by impedance measurements if the array is as large as the one being tested. The impedance changes are of approximately the same order of magnitude as the variation one obtains measuring different intact arrays.

Figure 3. Same setup as data in Figure 2 but with subarray AE265 disconnected at the subarray driving point.

Figure 5. Same setup as for data in Figure 2 but with subarrays AE265 and AE279 disconnected at the Tee-junction.

Figure 4. Same setup as for data in Figure 2 but with subarrays AE265 and AE301 disconnected at the driving point.

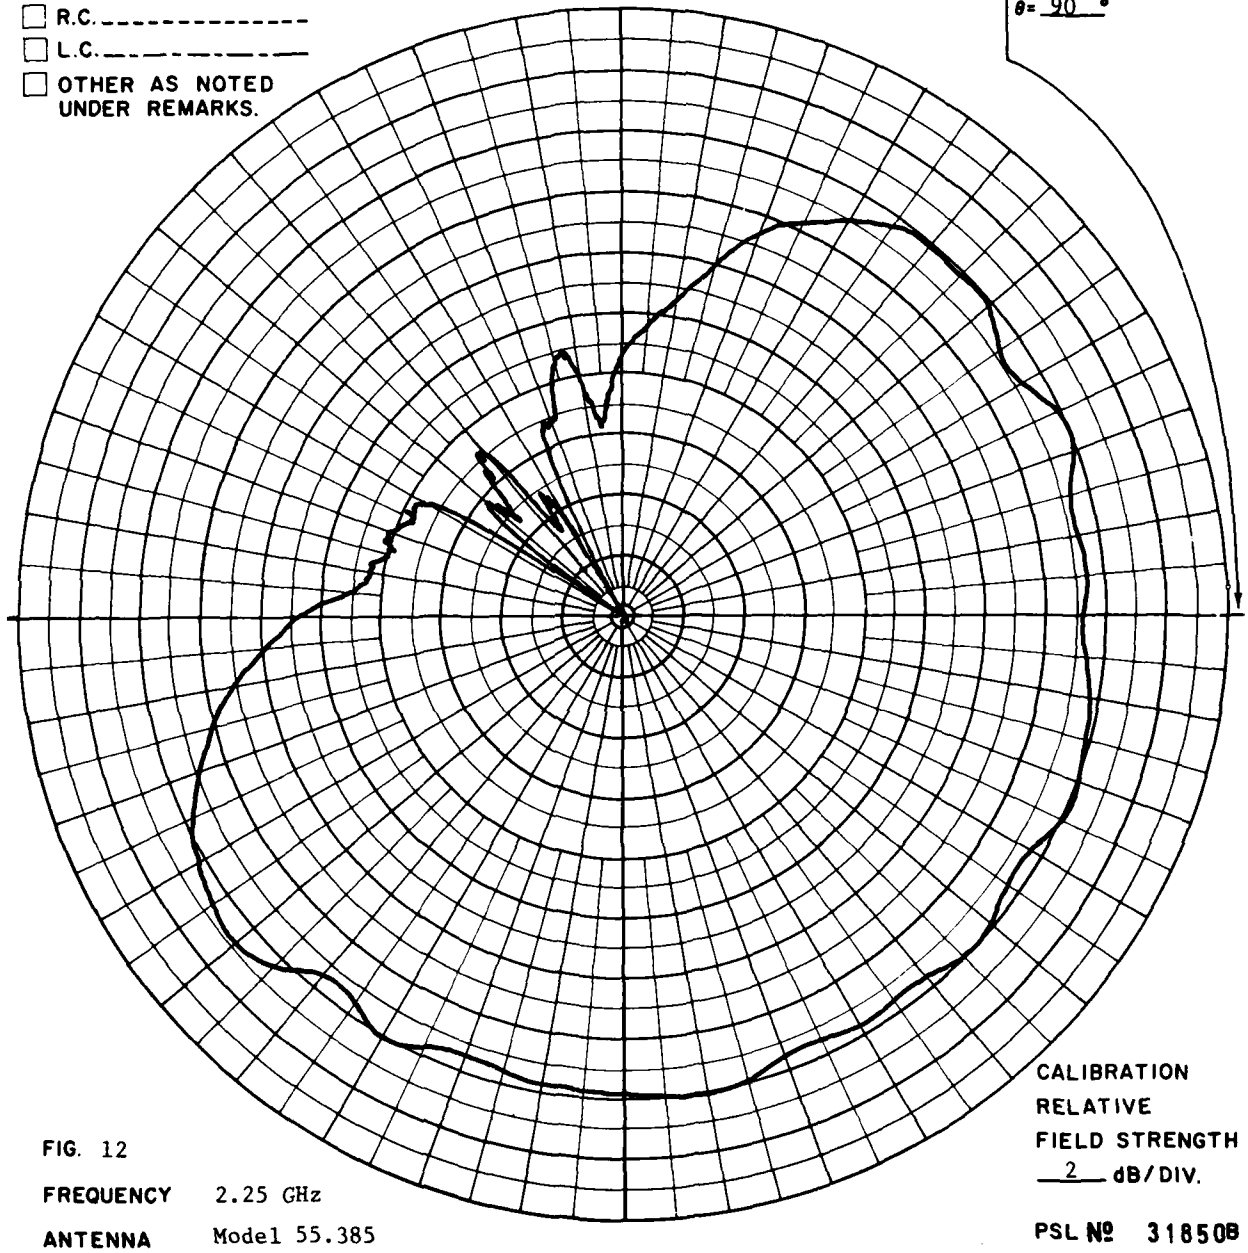
FIG. 12

REMARKS Far-field pattern. Two subarrays disconnected.

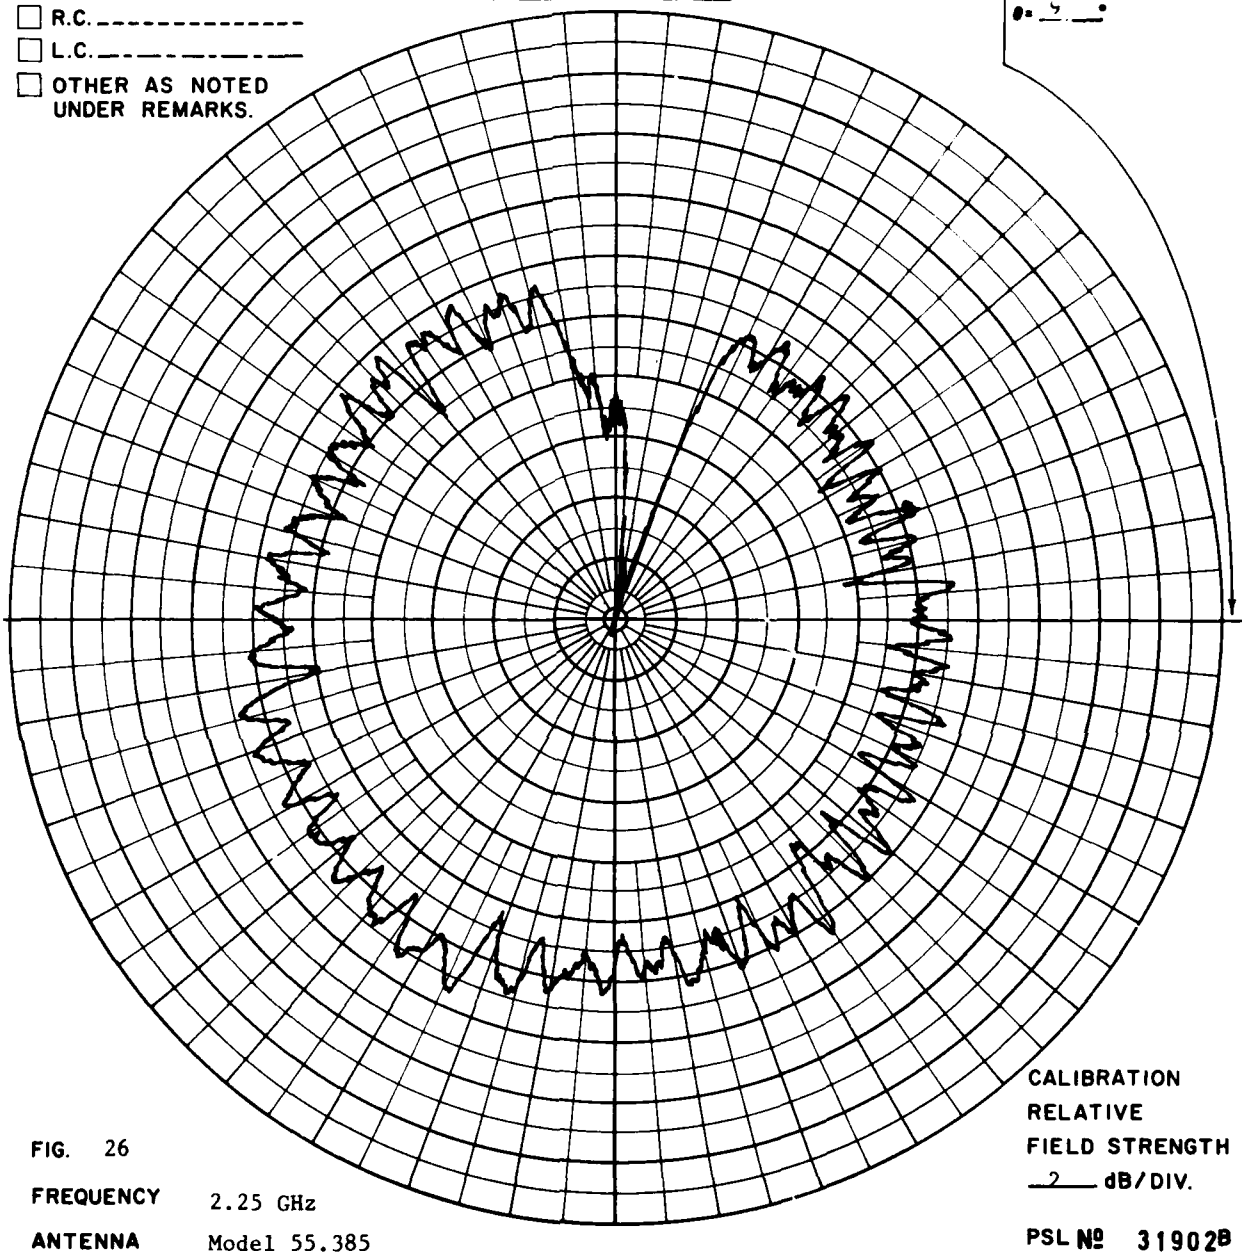
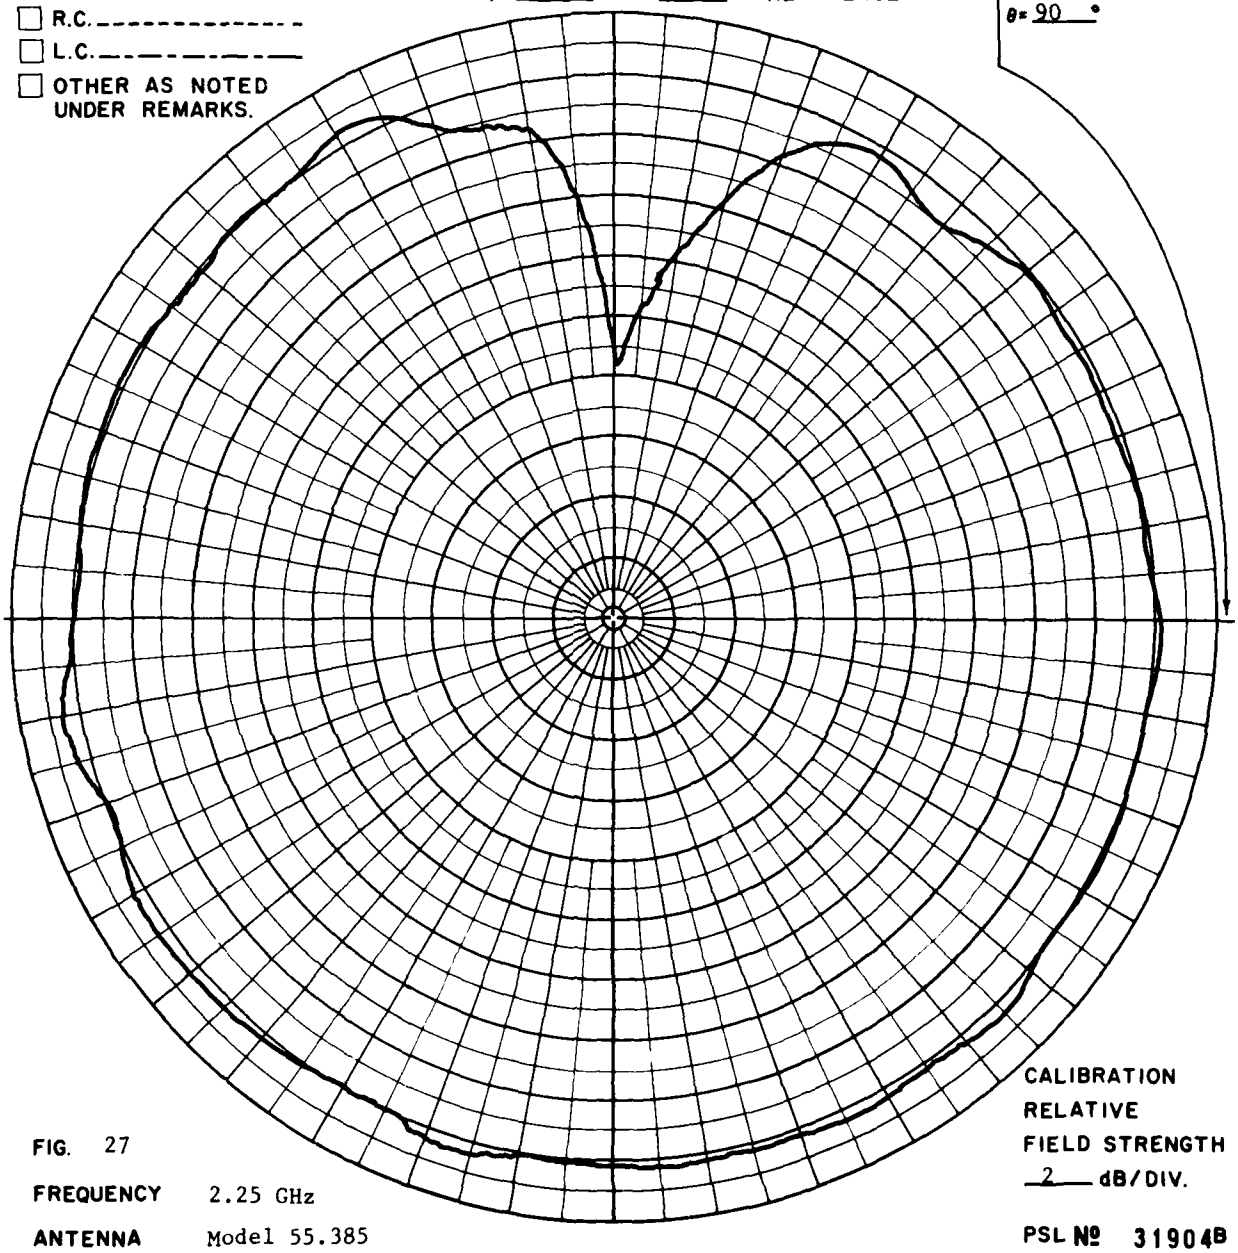
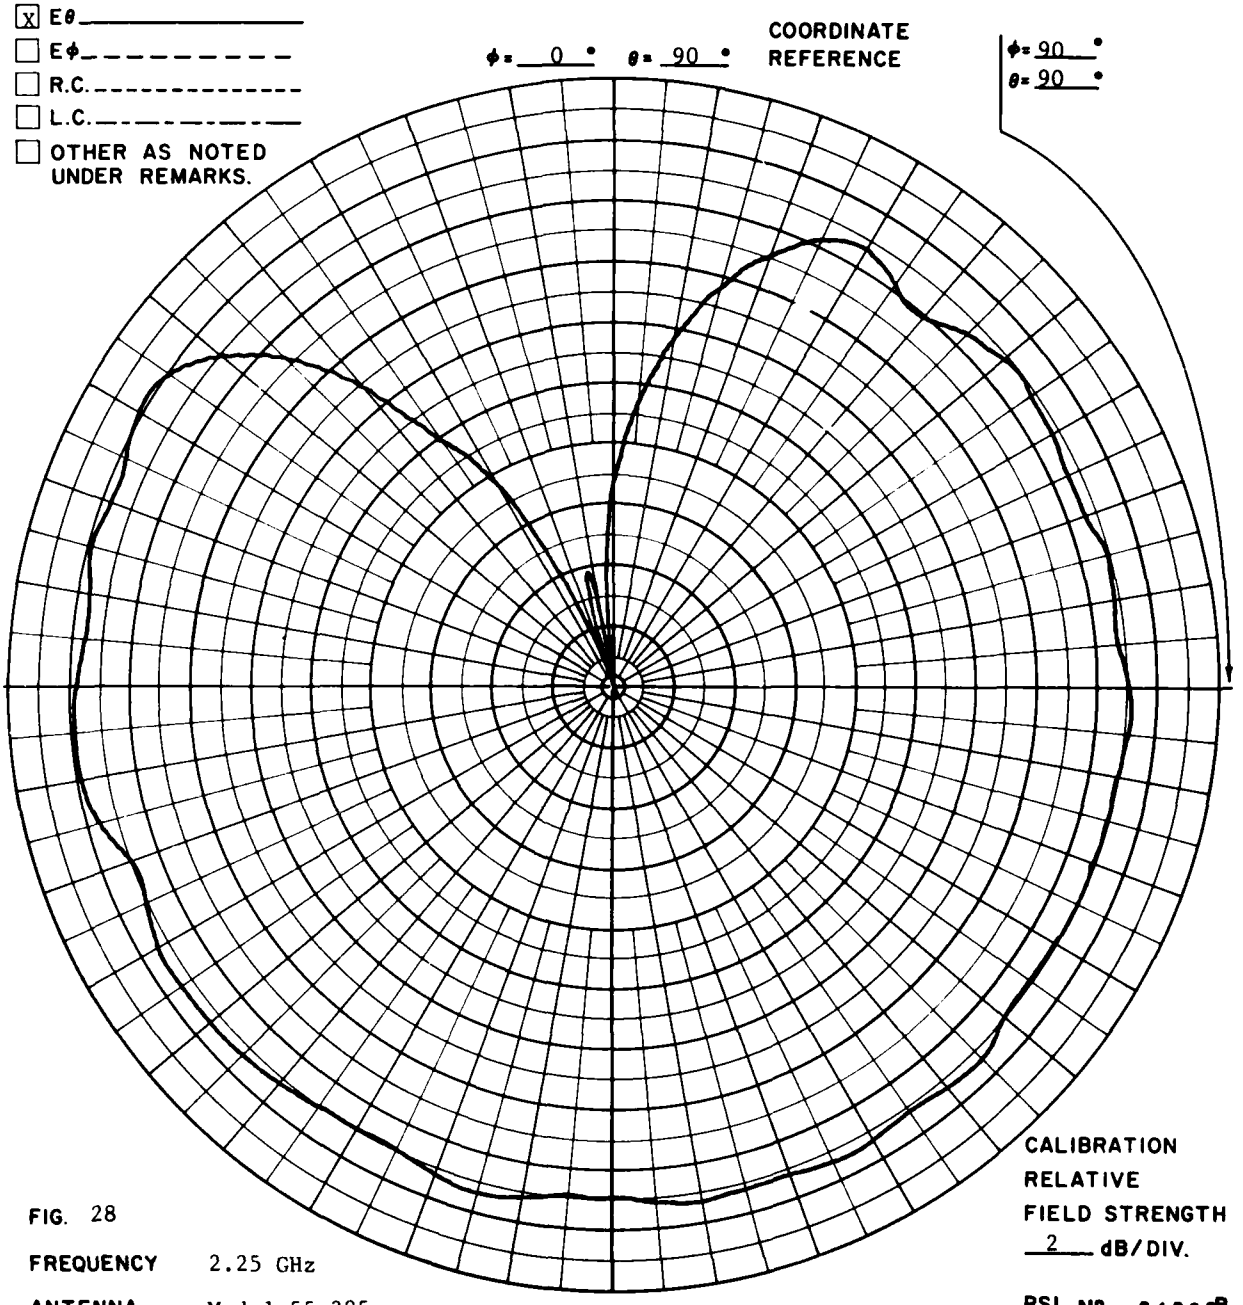
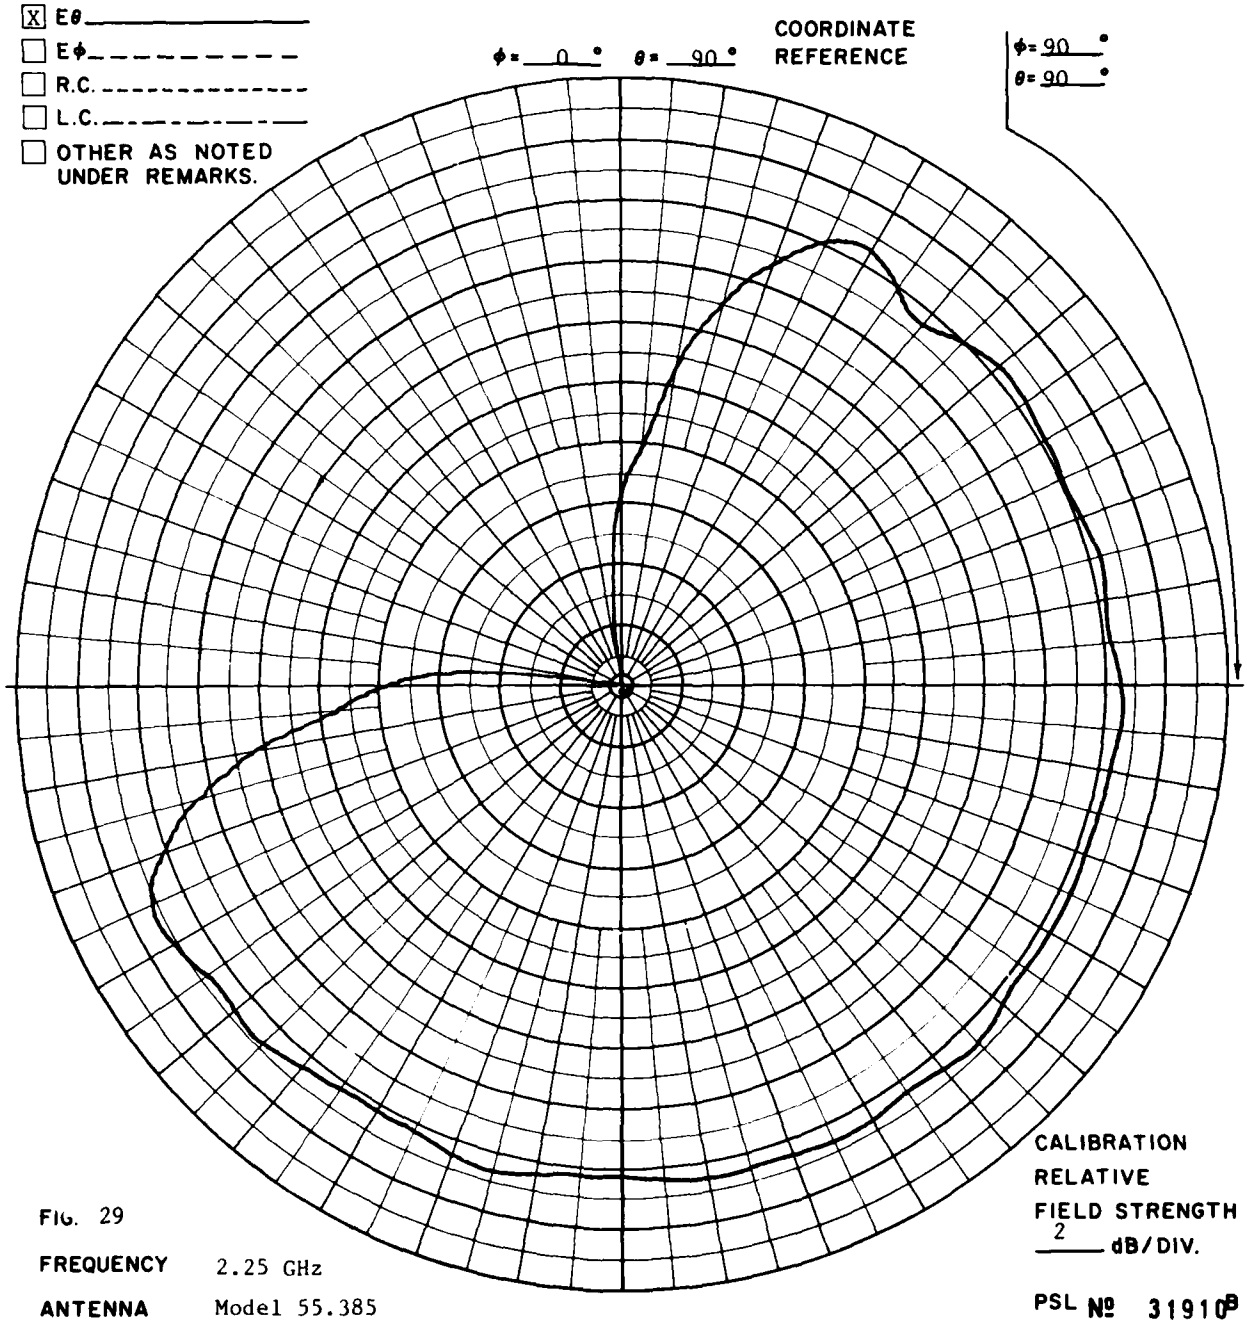
The patterns in Figures 26 through 29 show the result of simulated cable damages. A line break in the printed circuit harness was simulated by covering one of the slots with aluminum foil. The result was a sharp null which could be easily detected by either probe. Similarly a break of the coaxial cable was simulated by disconnecting the cables that feed one or two subarrays. The corresponding far-field patterns are shown in Figures 10 and 12. The data shows that there would be no problem detecting a nonfunctioning element or subarray.

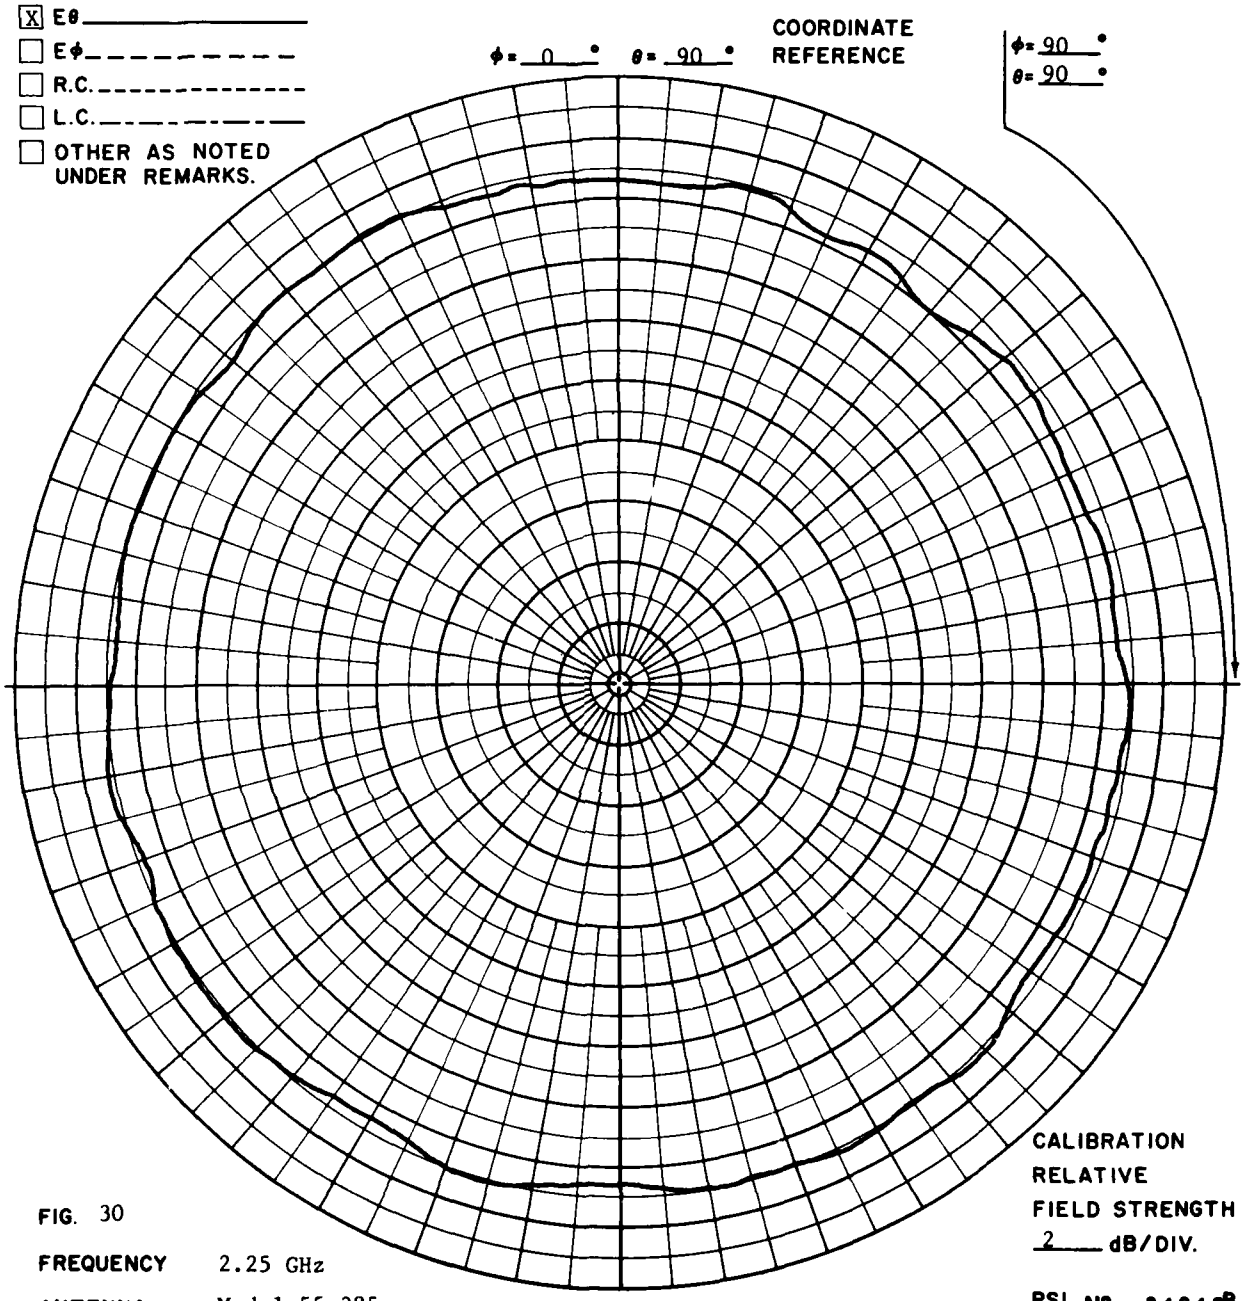
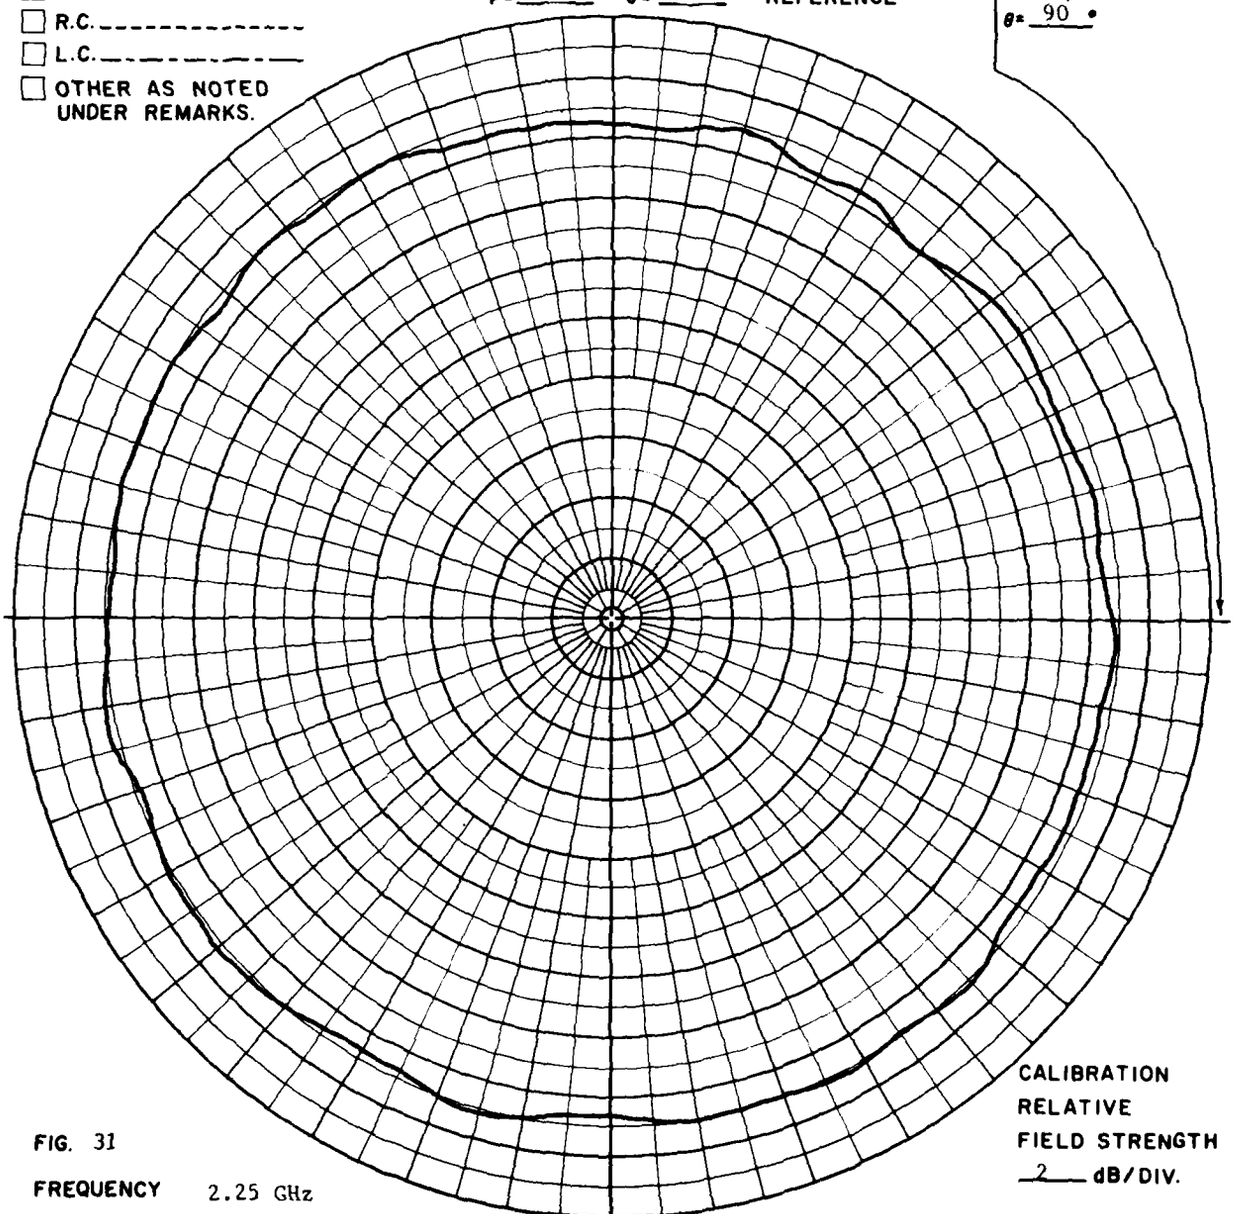
FIG. 30

A defect that would not be detected by either far-field or near-field probe measurements is illustrated in Figures 30 and 31. Connectors in the feed harness were loosened without obtaining any distinctive change in the radiation pattern. In flight the condition would probably produce RF noise due to mechanical vibration.

REMARKS Coaxial to waveguide adaptor probe. Connector loosened at antenna feed.

REMARKS Coaxial to waveguide adaptor probe. Connector loosened at three-way power divider.

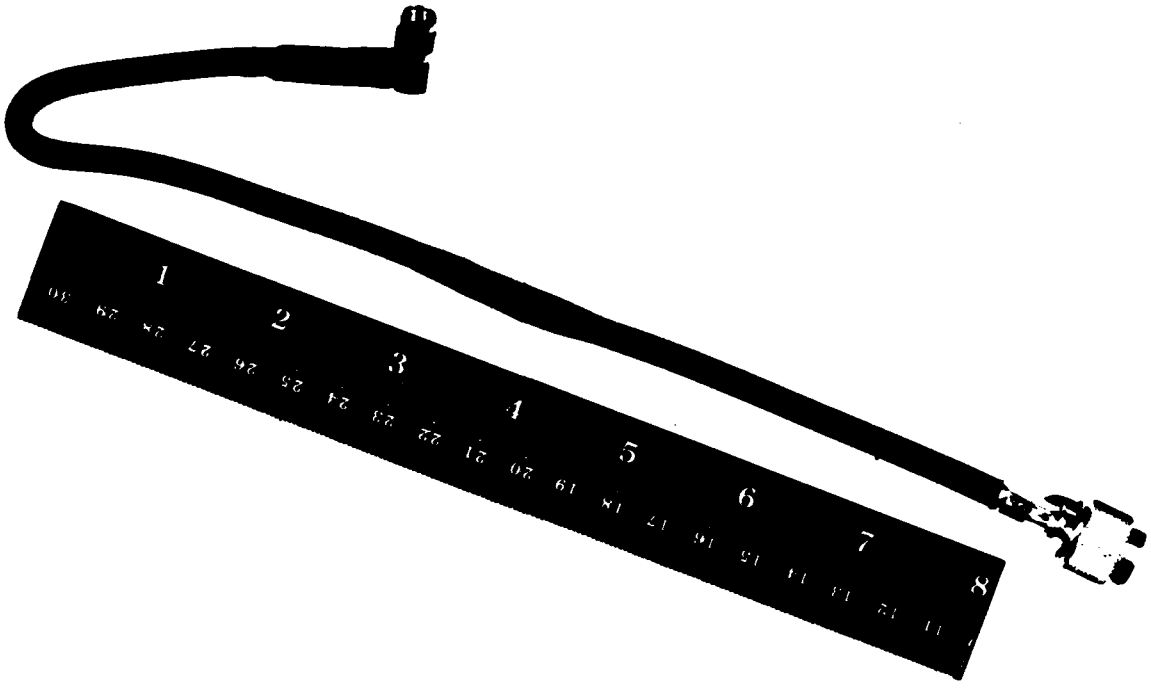
Figure 32. Damaged coaxial cable.

Another condition that may go undetected is illustrated by the patterns in Figures 33 through 44. The coaxial harness cables were deliberately bent and pinched as shown in Figure 32. This produced an intermittent problem which made detection uncertain. The implication is that great care needs to be exercised during the installation of the harness since a preflight probe is not a reliable method for detecting loose connectors or damaged cables.
